**ABC GRINDING CANADA INC.**

**Another "insitu" crankshaft repair...  
on time and on budget...**

## **PIELSTICK PC4V 14 CYLINDERS INSITU CRANKSHAFT REGRIND**

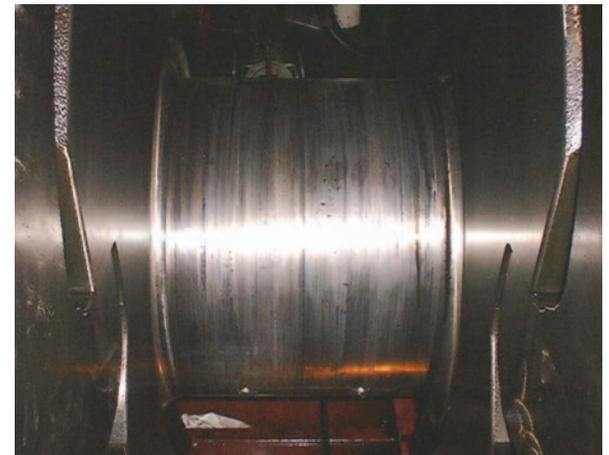
The damaged engine was on a cape sized bulk-er. This engine was built at Tsurumi Works by Nippon Kokan SEMT Pielstick in March 1982. After more than 22 years of continuous duty, the cam wear of this crankshaft caused an over heating of one crankpin bearing which resulted in deep scratches and heat damaged areas on the crankpin surfaces.

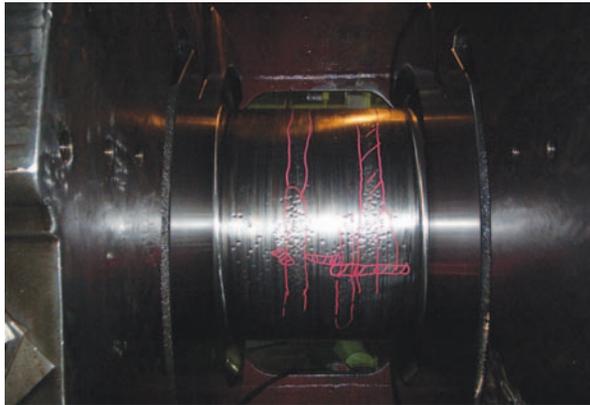
The first task was to determine the extent of the damage to the crankpins and to the main journals. We calibrated and tested the following :

- Maximum and minimum diameters, taper and wear of each crankpin and main journal.
- Connecting rod bores, for dimensions and wear.
- The run out of each main journal to check for bents in the crankshaft.
- Extent of cam wear in each of the crankpin.
- Complete non destructive testing using magnetic particles and ultra-violet lamp for heat cracks both on the surface and the sub surface of the crankpins and main journals.
- Comprehensive testing and profiling of hard spots and bands on the damaged crankpin.
- Conditions of the existing bearings

At conclusion of our tests we decided :

Crankpin # 6 must be ground 3mm undersize to remove hard spots and heat cracks.

All other crankpins must be ground 1mm undersize to remove the ridges from the cam wear.

All main journals must be polished to remove surface scratches.

The crankshaft was bent in way of main journals # 6 and 7 and has to be straightened.

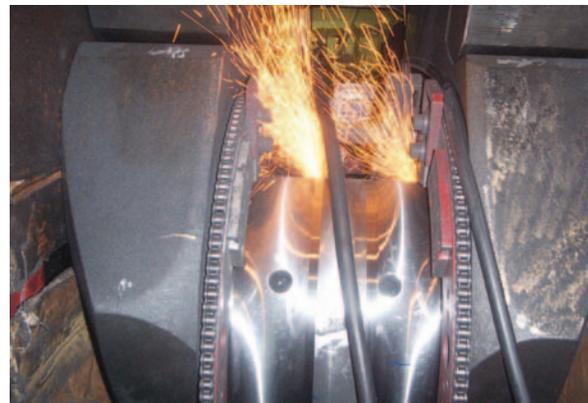
The crankshaft had suffered a heat induced bent in way of main journals # 6 and #7. The solution lies in stress relieve and this was achieved by using a peening hammer on the heat affected areas of crankpin # 6. At completion of this stage of the repairs, the run-out of the crankshaft was restored to 0.03mm which was exactly at Builder's Specifications.

All the crankpins were ground to the specification sizes. Work was carried out on 24 hours basis using 2 grinding turbines to speed up the repairs.

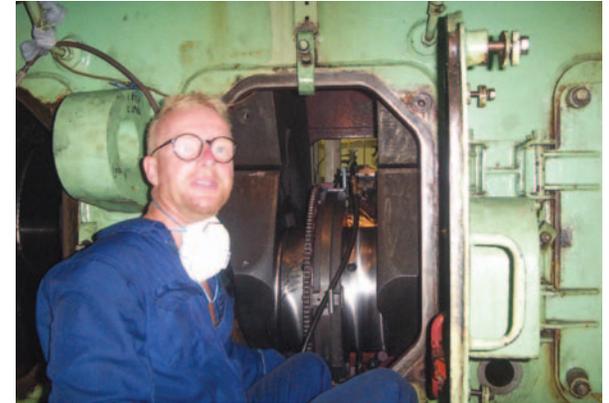
Magnetic Particle Inspection tools were used to check on presence and conditions of heat cracks.

In house quality control system requires that these grinding repairs were monitored on a daily basis with the following checks:

All micrometers were calibrated using "Standard" bars.
